PROPERTY INSPECTION REPORT - Example

Concerning: Anystreet, Anytown Texas
(Address or Other Identification of Inspected Property)

By: Jeff Wampler TREC# 5592
Sheldon Conrad TREC# 9974
(Name and License Number of Inspector) (Date)

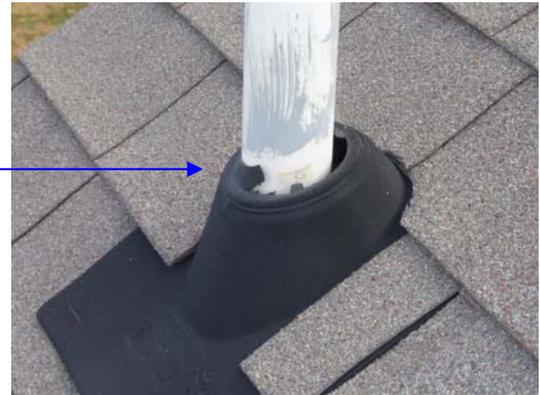
- Observed a vent stack “boot” on the rear elevation of the house which has deteriorated and should be repaired or replaced.

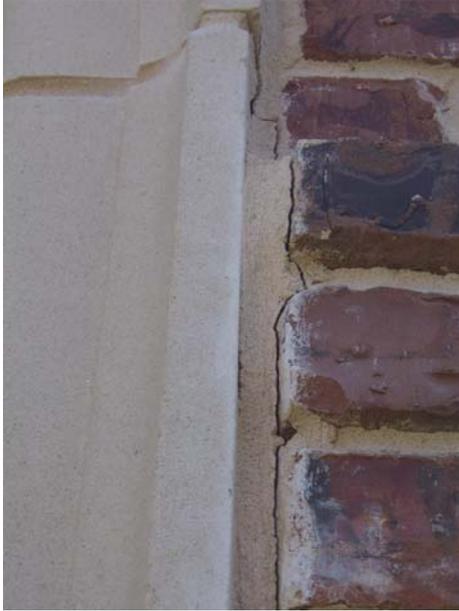
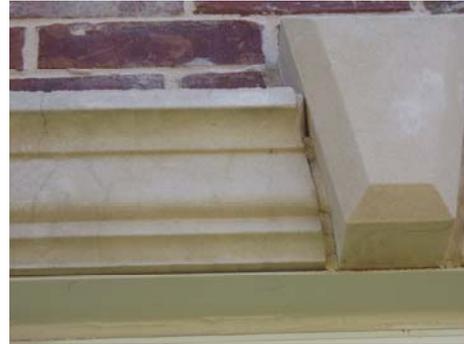
- Observed some minor mortar cracking in the concrete coping around some of the front windows and over the single garage. This condition is typical, and should be monitored. Any cracks or gaps should be filled as necessary to avoid water penetration.

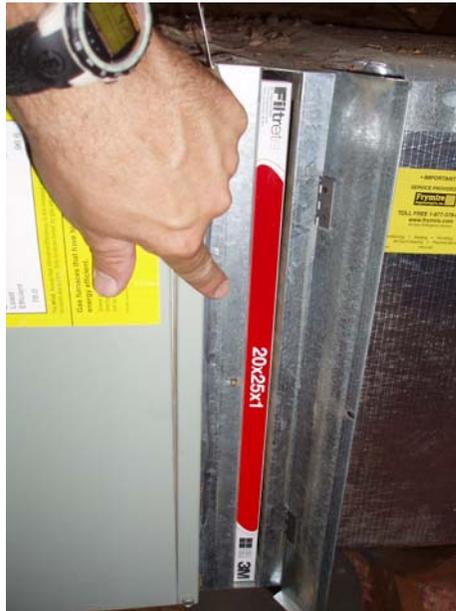
Inspector Note: All filters are 20 x 25 x 1 – all located in the attic.

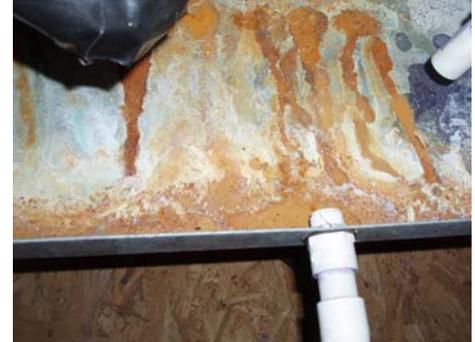
- Observed rust in the bottom of the secondary drain pan of the attic portion of the north AC unit. Recommend this be serviced by a licensed HVAC technician if the unit has not been serviced in the last 6 months.

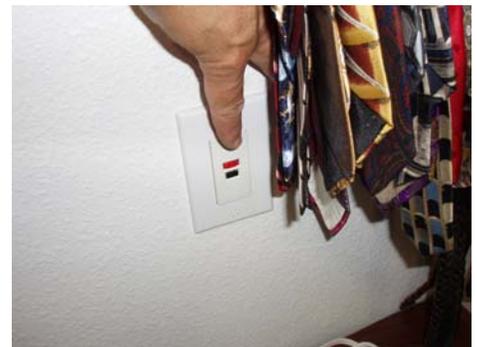
- The GFCI switch for the Jacuzzi (located in the master bedroom closet) will not trip. Recommend replacing the switch.
